Subject: 2015 MMGL Corp. Doane Lake Annual Inspection Report, ESCI Site ID No. 395

PREPARED FOR: Brenda Anderson/MMGL
PREPARED BY: Aaron Leritz/Bridgewater Group, Inc.

DATE: September 24, 2015

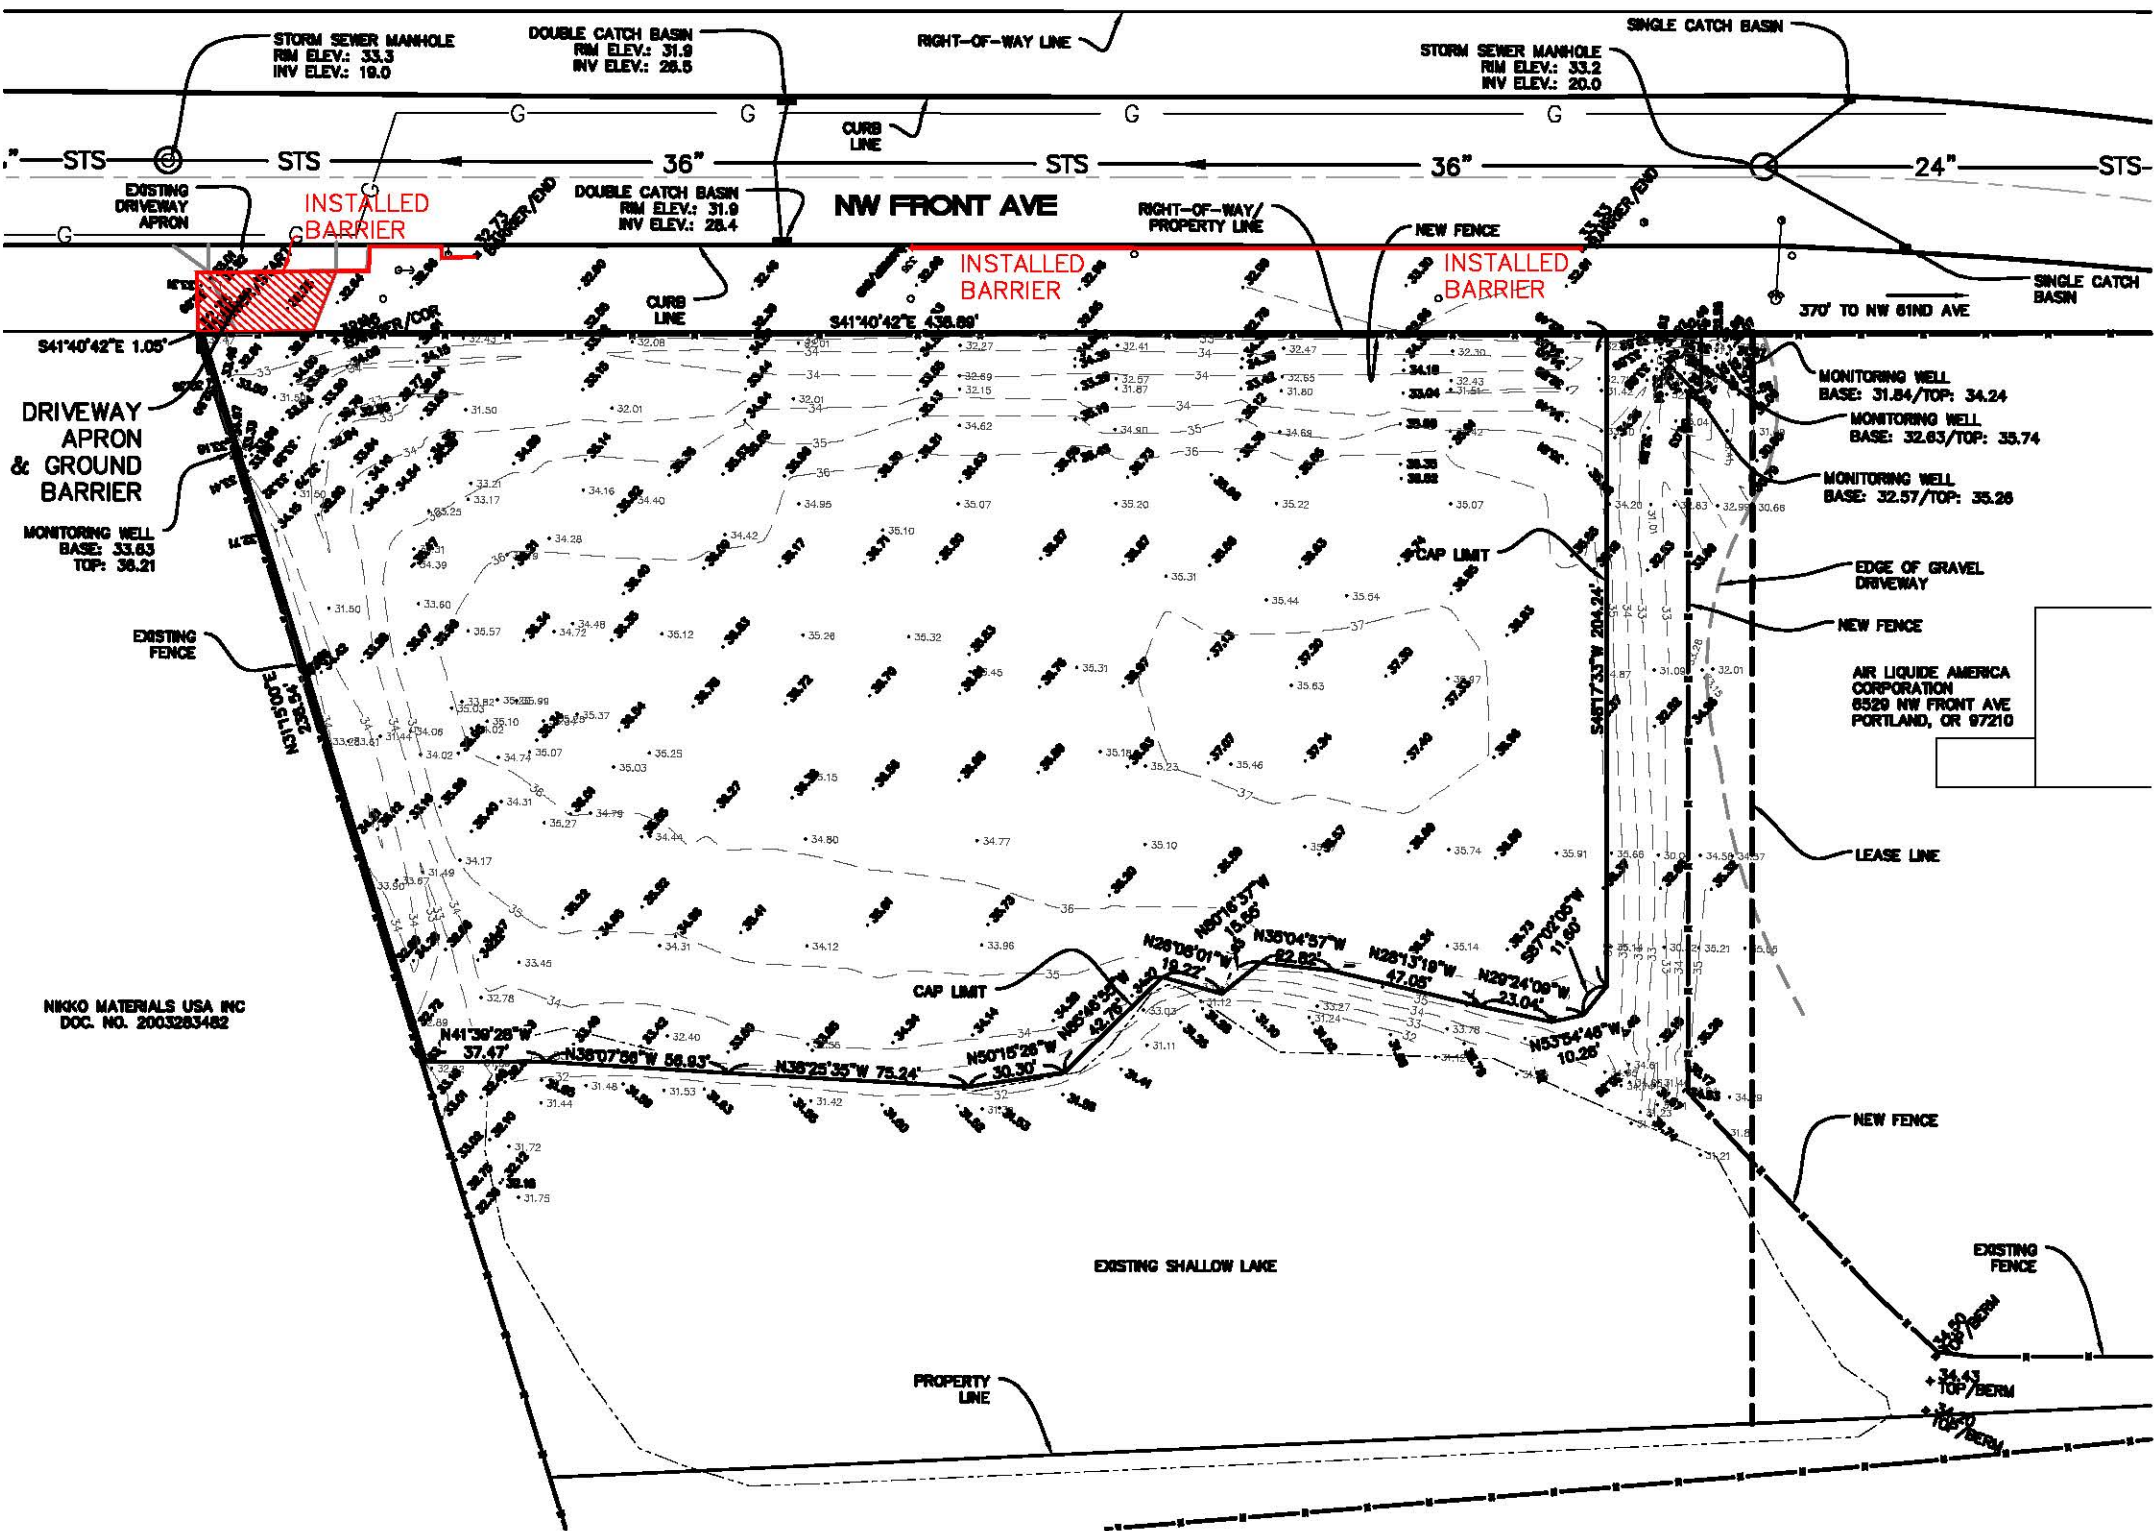
Figure 4
As-Built Drawing
Doane Lake Source Control Action
MMGL Corp.

Results. As discussed above, an area approximately 20 feet by 20 feet settled near the northeast corner of the Site allowing stormwater to pond (Figure 4). Another smaller area (approximately 10 feet by 10 feet) was observed in the southeast portion of the Site. This area was also repaired during the August 2015 cap augmentation project.

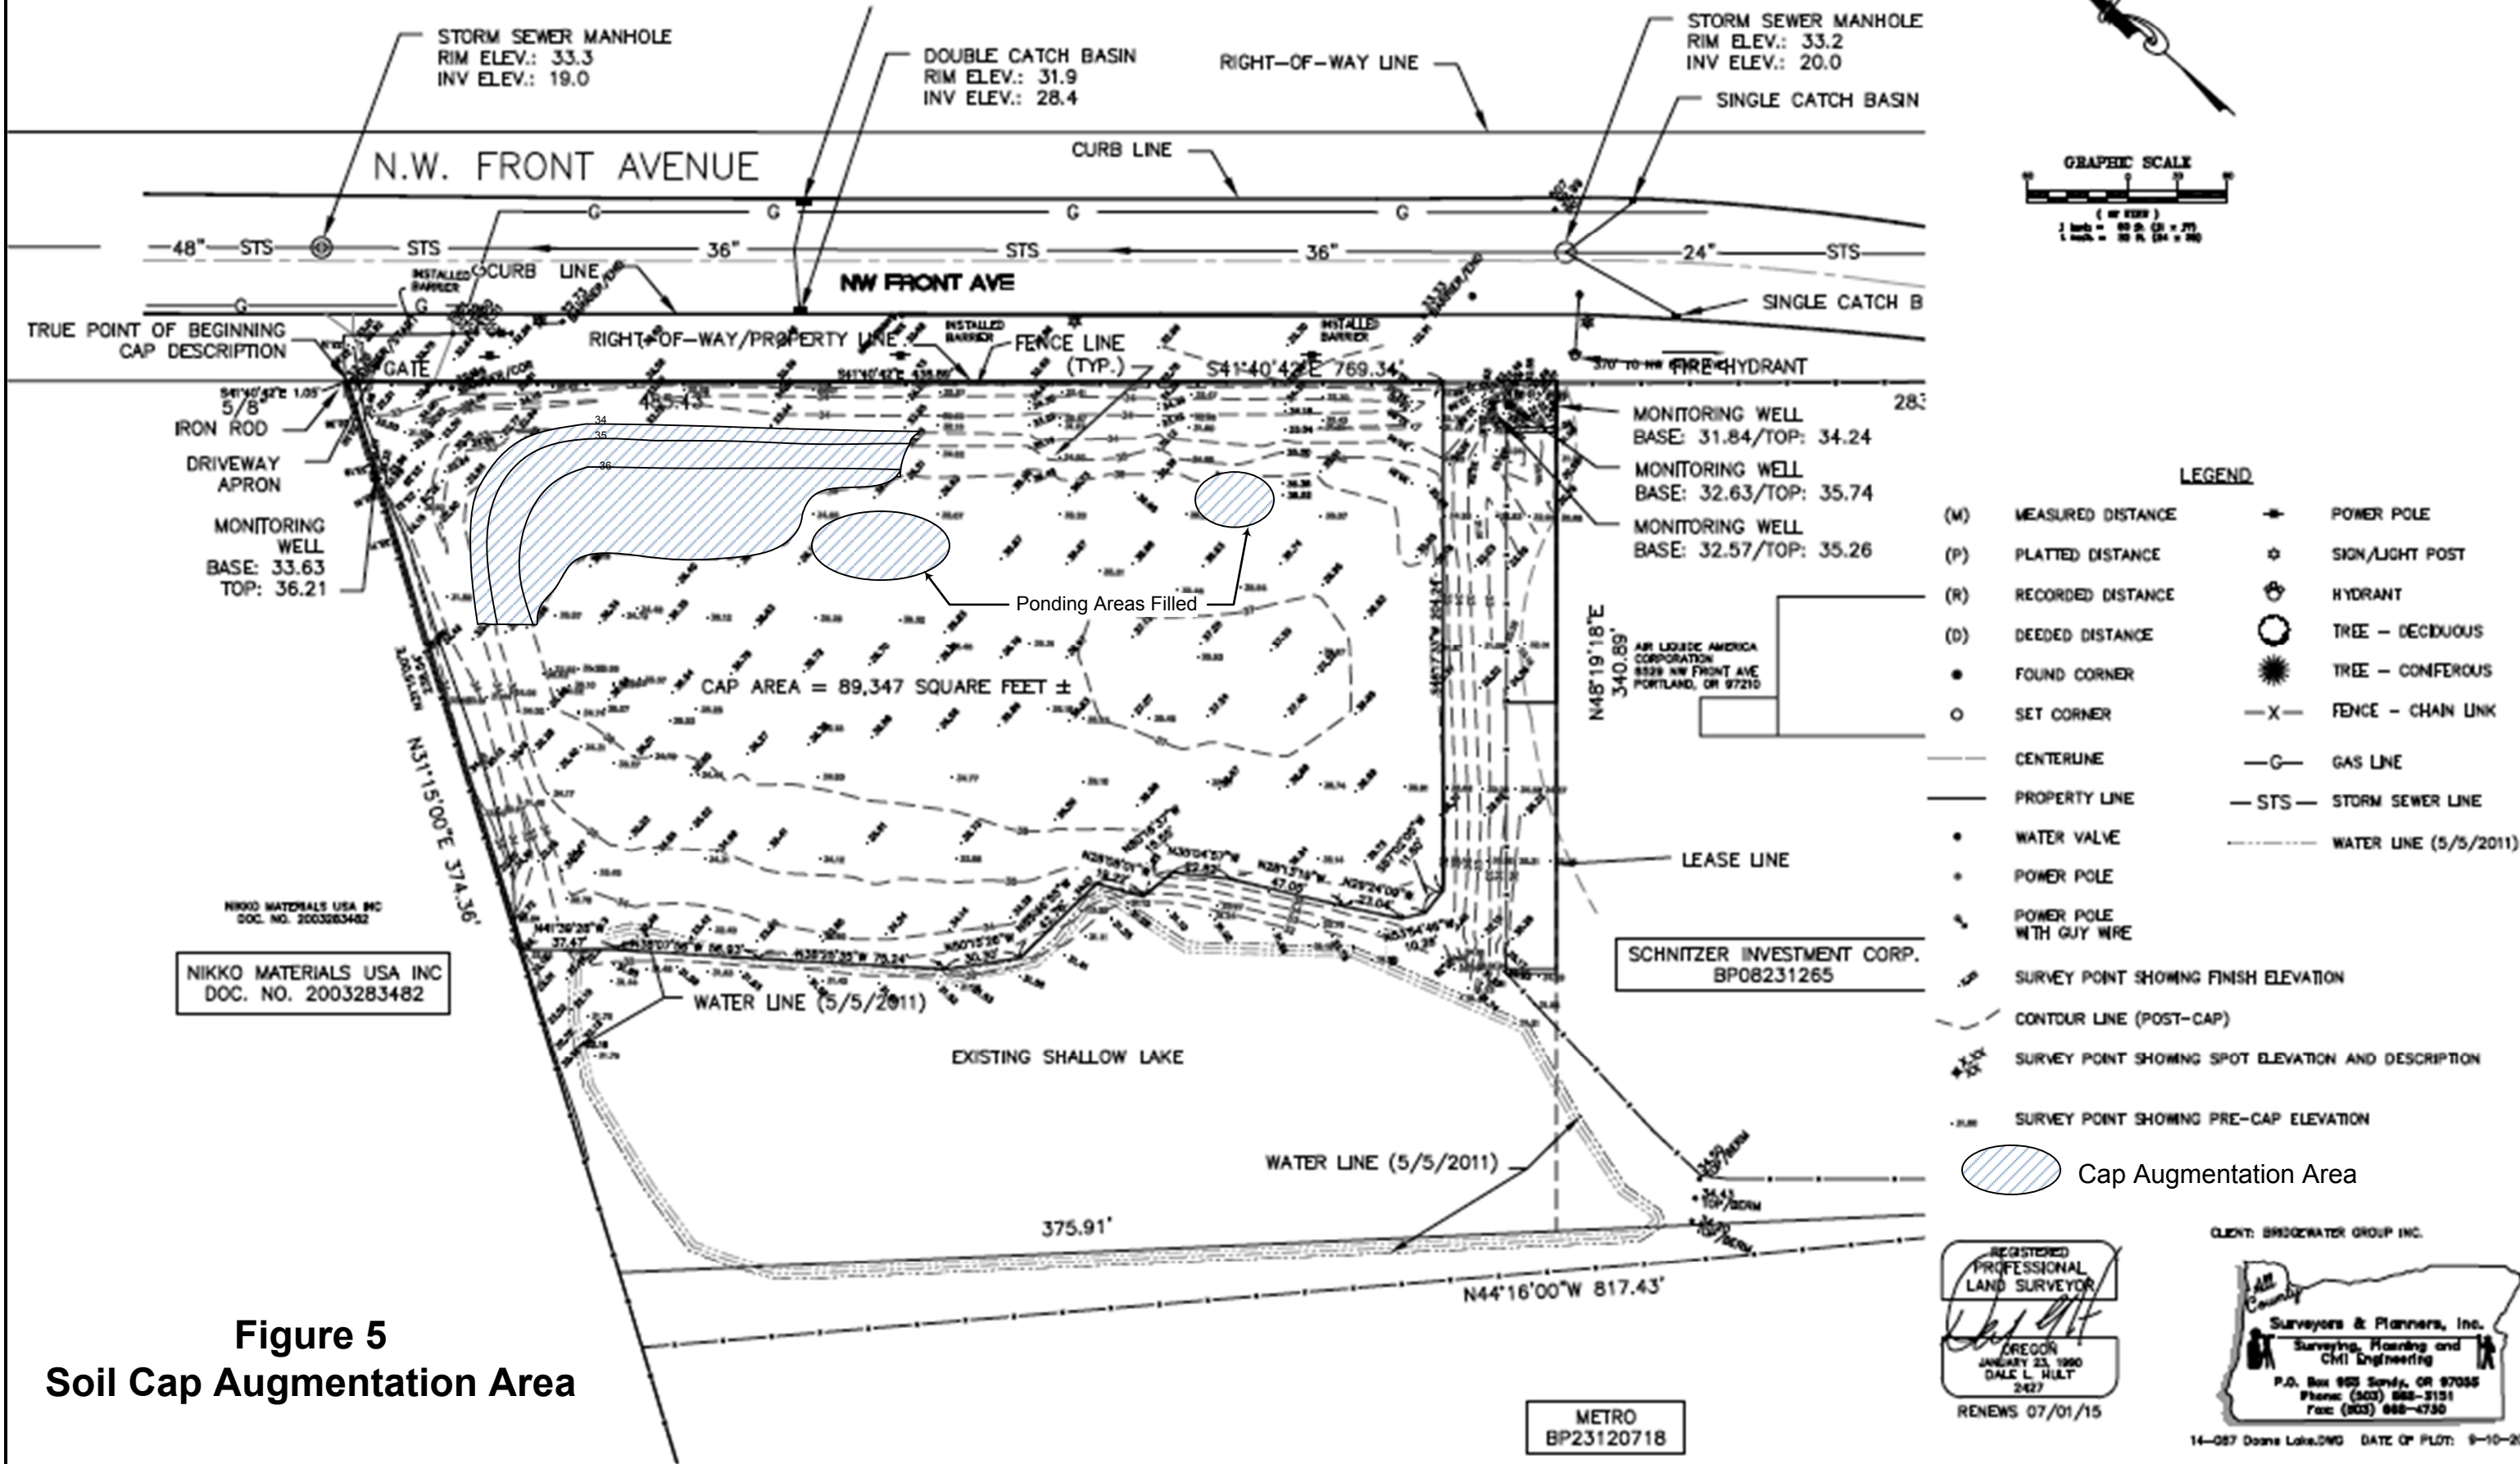
Figure 5
Soil Cap Augmentation Area

The cap augmentation work was completed in August 2015. Figure 5 shows the area of the cap augmentation work. Photographs of the cap augmentation work are provided in the photograph log provided in Attachment A.

At the request of DEQ, MMGL implemented a cap augmentation project in August 2015 to eliminate the ponding and raise the grade in the northeast portion of the Site to prevent continued or future erosion issues. The cap augmentation included the following:

- Stripping and stockpiling approximately 11,000 square feet of the 6-inch layer of sandy loam top soil;
- Importing, grading, and compacting with the trackhoe, approximately 250 tons (approximately 190 cubic yards) of Knife River quarry material (well-graded sand and gravel with less than 20 percent fines per the cap specifications and work plan);
- Re-grading and compacting the top soil over the quarry material; and
- Applying hydroseed to all disturbed areas of the Site.

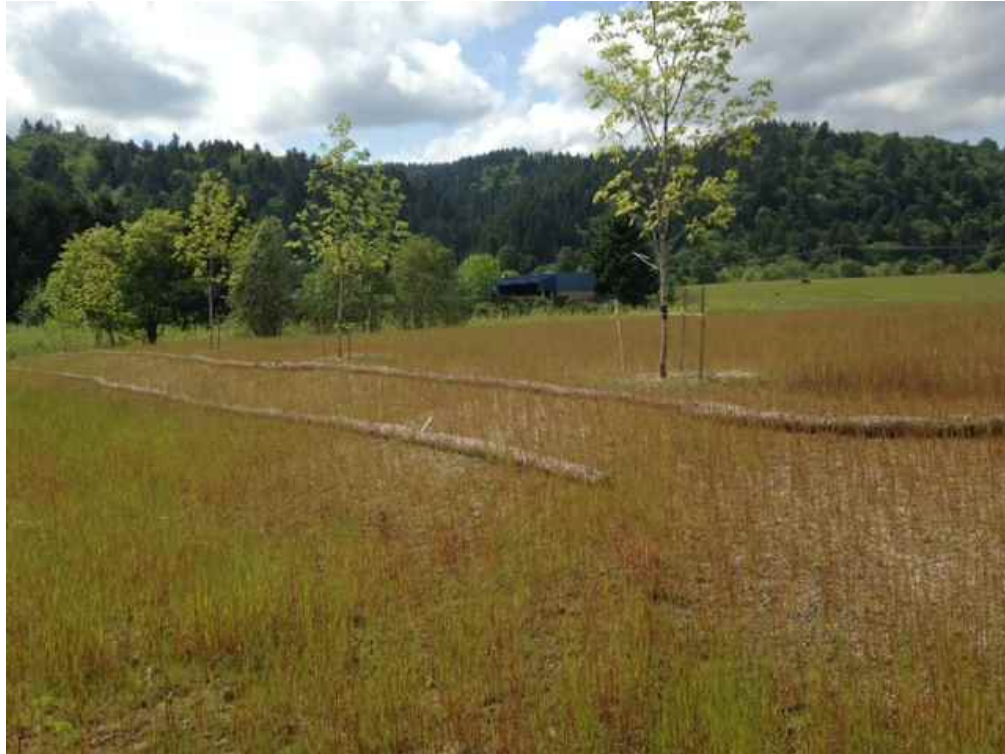
Doane Lake May 4, 2015. South swale and cap area.

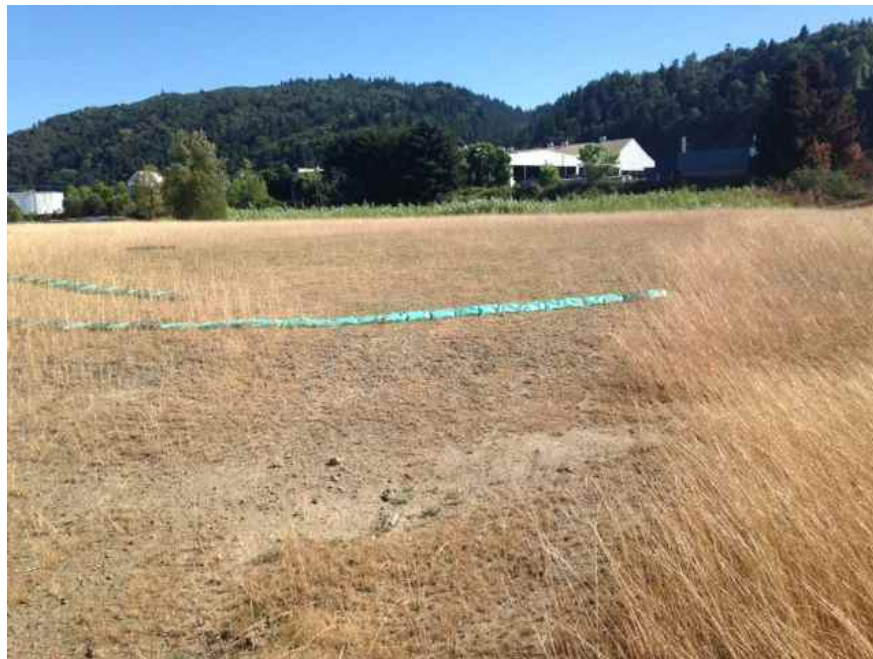
Doane Lake June 30, 2015. Northeast corner of cap area.

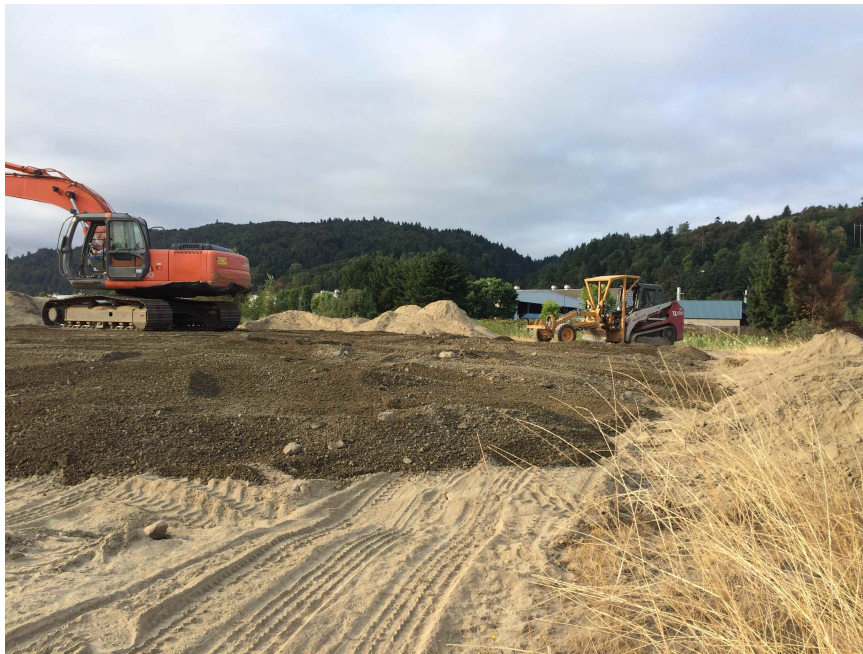
Doane Lake August 10, 2015. Cap augmentation northeast corner. Grading quarry material.
